Figure 3-1a

Basin A

YARROW POINT DRAINAGE SYSTEM

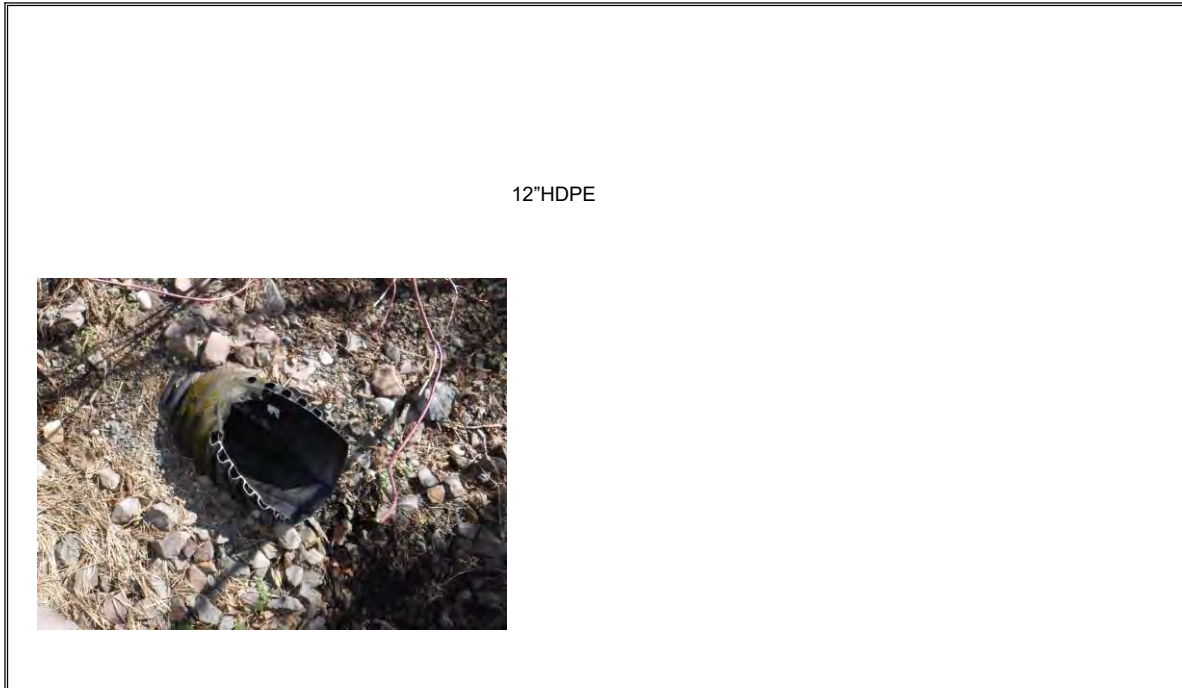
BASIN: A
STRUCTURE NO. A-17

Comments: Permitted 2006.

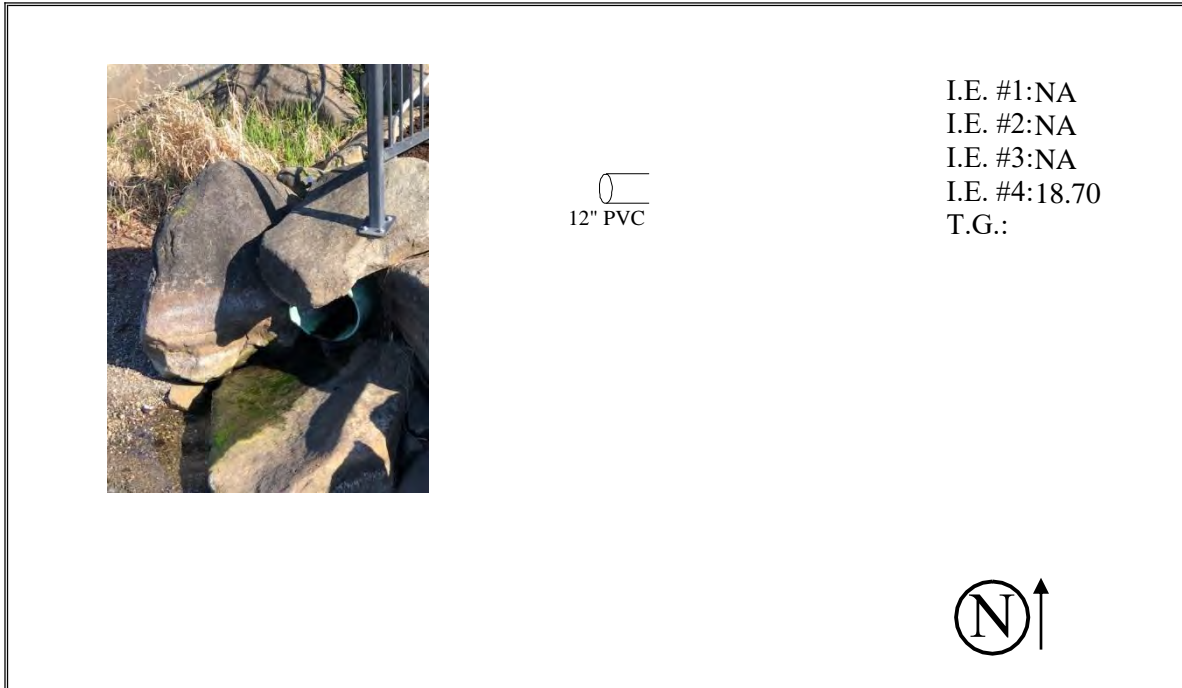
BASIN: C
STRUCTURE NO. C-9

Comments: UNABLE TO ACCESS. ON PRIVATE PROPERTY.

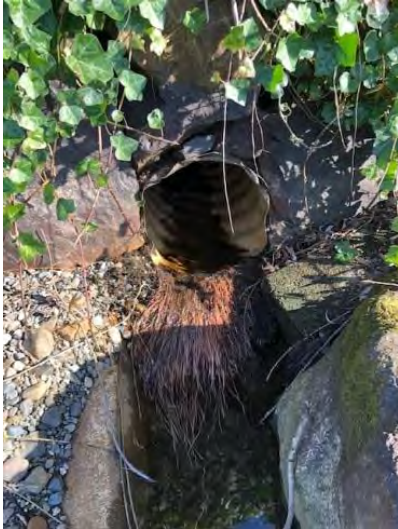
STRUCTURE NO. E-9

Comments: Minor root blockages in pipe noted during 2018 annual clean and camera.

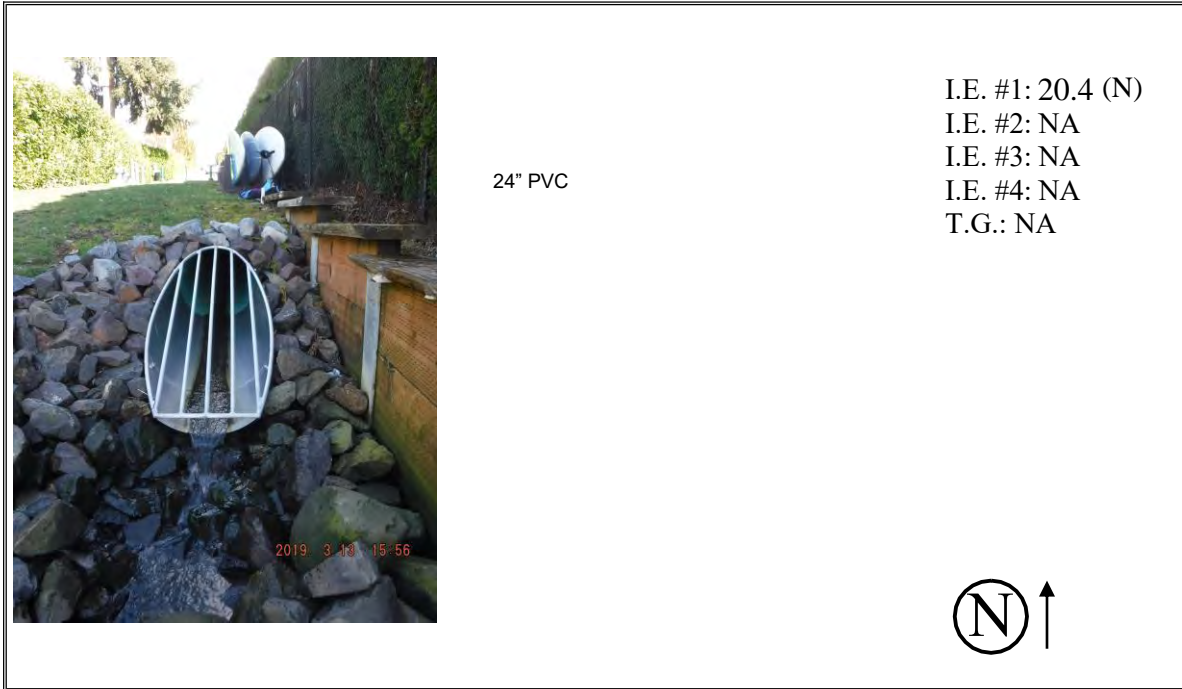
BASIN: G
STRUCTURE NO. G-80

Comments: APPROX. AGE 6 years; Installed 2014. Clean and video 2018; platted 1968.
