# **Arborist Report**

То:	Town of Yarrow Point, c/o Stacia Schroeder
Site:	Right-of-Way fronting 3829 95 <sup>th</sup> Ave NE
Re:	Tree Risk Assessment
Date:	May 13, 2021
Project Arborist:	Haley Galbraith ISA Board Certified Master Arborist PN-7512BM ISA Qualified Tree Risk Assessor
Attached:	Table of Trees

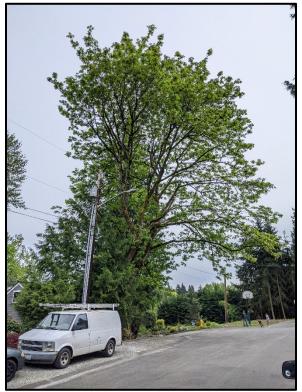
Photo 1. Looking south along 95<sup>th</sup> Ave NE at subject maple tree in ROW.

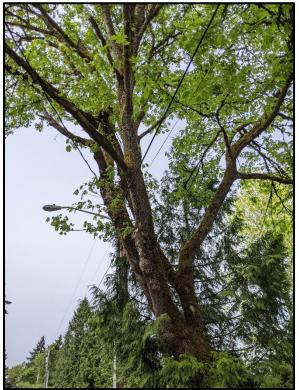
The tree appeared to be in fair health and structural condition at the time of my assessment, however, following advanced testing at three points around the base of the tree, I rated the structural condition of the tree as poor. The tree measured 32.1 inches in diameter at standard height (DSH) and approximately 60 feet tall. I observed that the tree has a history of significant pruning for clearance of the power lines that run along 95<sup>th</sup> Ave NE and are in contact with the tree in some places (see Photo 2). Past pruning cuts had varying degrees of decay visible.

Photo 2. Power lines running along east side of 95<sup>th</sup> Ave NE in contact with tree in some places.

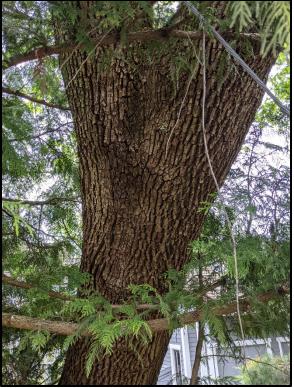
The base of the tree grows at an angle to the west, toward the roadway, and then corrects upward at roughly eight feet above grade. At this point, there is a narrowly-attached co-dominant union. There is a poor trunk to branch diameter ratio at this point, meaning that each of the two co-dominant leads are larger than the trunk below where they are attached (see Photo 3).

Photo 3. Co-dominant union of maple tree at roughly eight feet above grade.

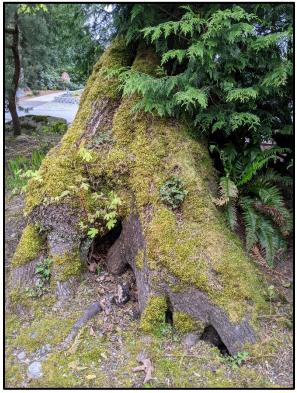
The west side of the tree base is resting against the stump of a formerly existing tree at grade level. The structural roots of the tree appear stilted, as if the whole tree originally grew over a stump which is now mostly gone. On the east side, several openings between structural roots are visible (see Photo 4). Based on this observation, I decided to perform micro-resistance drill testing. The results of testing, which are included below, showed significant decay at each of the three points tested. Therefore, I believe the structural integrity of the tree is compromised and whole tree failure may occur under normal operating conditions within a five year time frame.

Photo 4. Looking west at east side of tree base where several openings between structural roots are visible.

• Based on the extent of decay I detected throughout the base of the tree, overall tree health and structural condition, and the presence/type of surrounding targets, I recommend that the subject tree be removed.

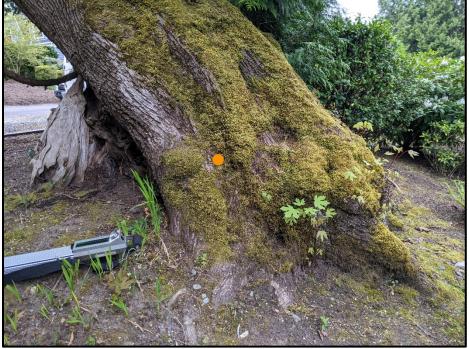
Photo 5. Looking north at south side of tree base; orange dot indicates location of drill test 1.

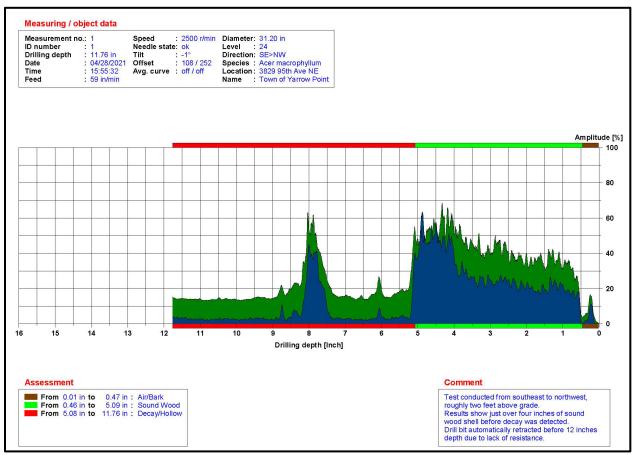
Figure 2. Results of drill test 1 show just over four inches of sound wood shell before decay was detected.

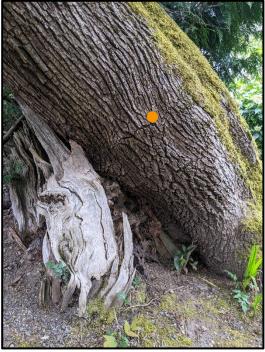
Photo 6. Looking north at south side of tree base; orange dot indicates location of drill test 2.

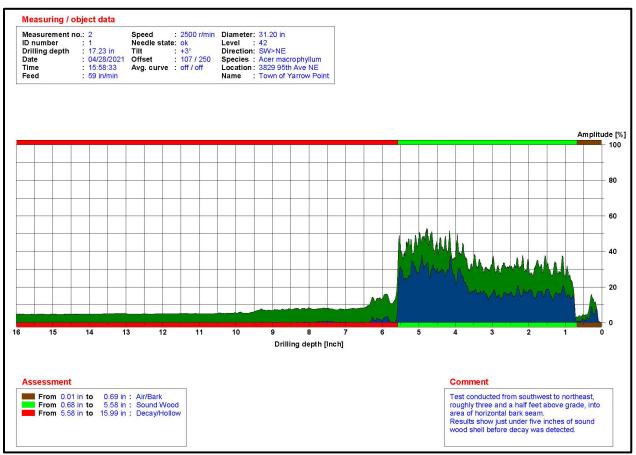
Figure 3. Results of drill test 2 show just under five inches of sound wood shell before decay was detected.

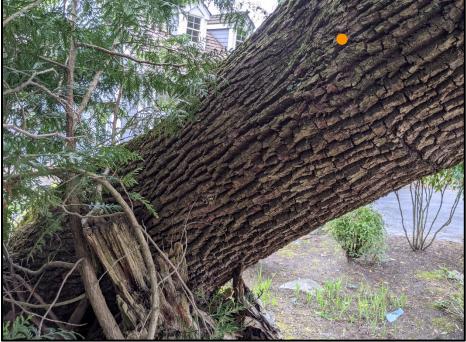
Photo 7. Looking at north side of tree trunk, roughly five feet above grade at location of drill test 3.

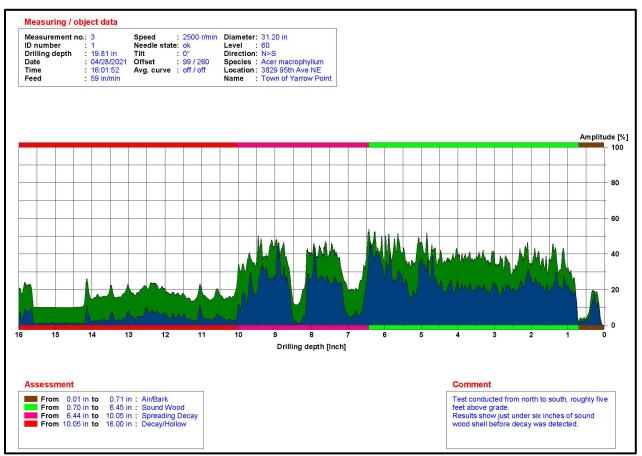
Figure 4. Results of drill test 3 show just under six inches of sound wood shell before decay was detected.
