# **Arborist Report**

То:	Town of Yarrow Point, c/o Stacia Schroeder
Site:	Right-of-Way fronting 3829 95 <sup>th</sup> Ave NE
Re:	Tree Risk Assessment
Date:	May 13, 2021
Project Arborist:	Haley Galbraith ISA Board Certified Master Arborist PN-7512BM ISA Qualified Tree Risk Assessor
Attached:	Table of Trees

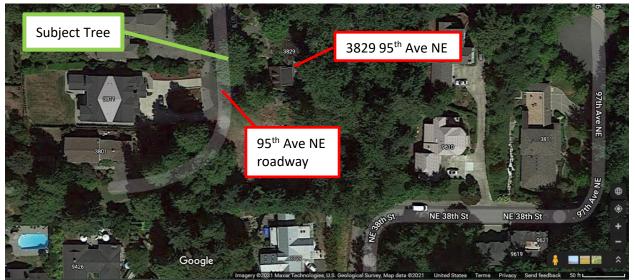
The subject maple tree is located on Town of Yarrow Point property, in the Right-of-Way (ROW), west of private property along 95<sup>th</sup> Ave NE. The tree location and surrounding targets are shown on the site map below (see Figure 1).

Figure 1. Aerial view of subject tree location and adjacent roadway. (Source: Google Maps, accessed May 13, 2021)
