Figure 3-1a

Basin A

YARROW POINT DRAINAGE SYSTEM

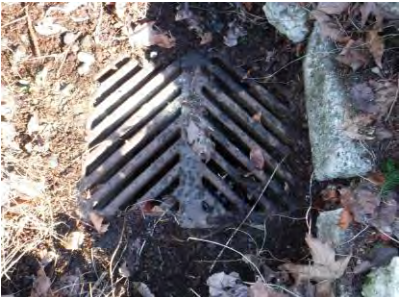
BASIN: A
STRUCTURE NO. A-1

Comments: CANNOT OPEN, HEAVY STONE ON TOP OF ONE EDGE.
Permitted 2014.

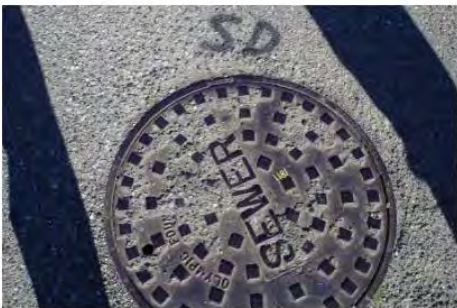
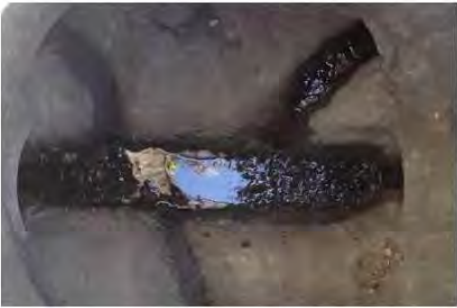
BASIN: D
STRUCTURE NO. D-14
1181

Comments: LOOSE BRICKS NEAR LID. APPROX. AGE 60 years.

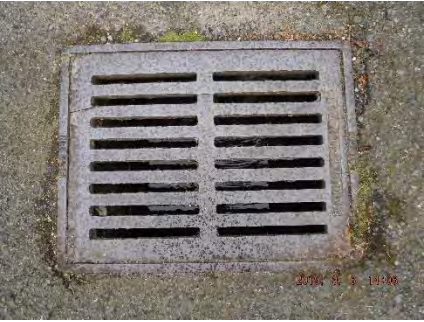
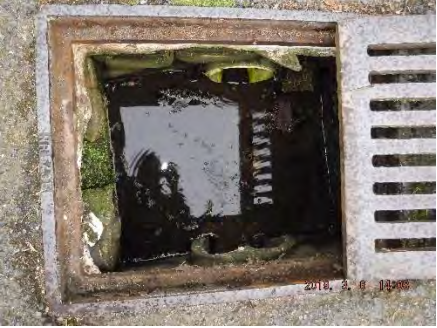
BASIN: D
STRUCTURE NO. D-15
1184

Comments: Loose bricks replaced in March 2019. Approx. age 60 years.

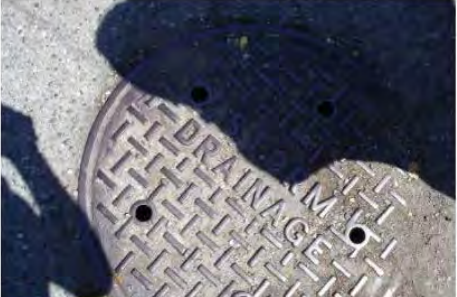
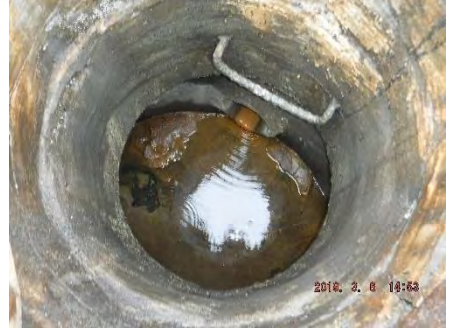
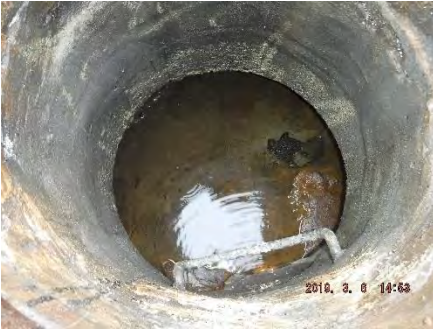
BASIN: E
 STRUCTURE NO. E-6
1168

Comments: Corrosion/Pollution in sump. Approx age 60 years; plated 1961; clean and video 2018.

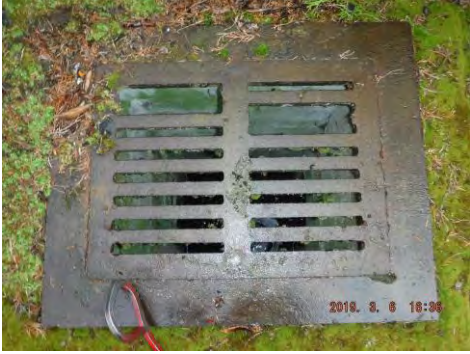
BASIN: F
 STRUCTURE NO. F-15
 1144

Comments: CANNOT OPEN GRATE. GRATE IS BROKEN.
 Approx age 50 years; plated 1968; clean and video 2018.

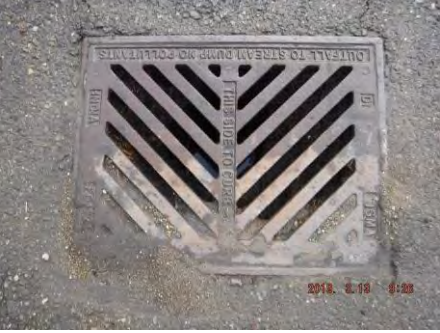
BASIN: G
 STRUCTURE NO. G-7
1002

I.E. #1: NA
 I.E. #2: 146.7 (E)
 I.E. #3: NA
 I.E. #4: NA
 T.G.: 148.8

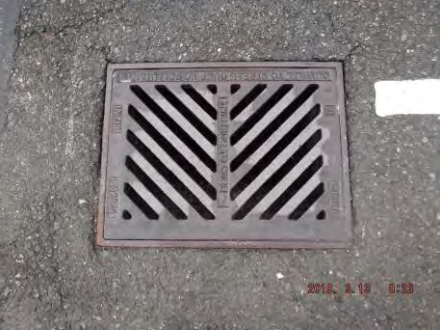
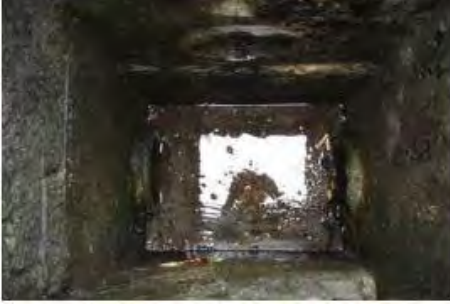
BASIN: G
 STRUCTURE NO. G-8
1001

I.E. #1: 144.8 (N)
 I.E. #2: 145.8 (E)
 I.E. #3: 144.7 (S)
 I.E. #4: 146.2 (W)
 T.G.: 148.8

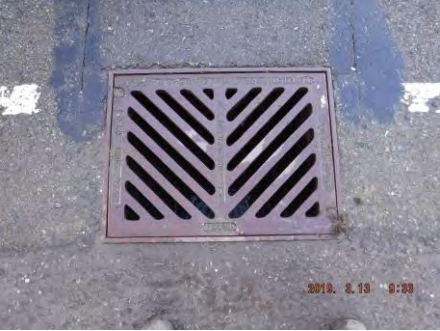
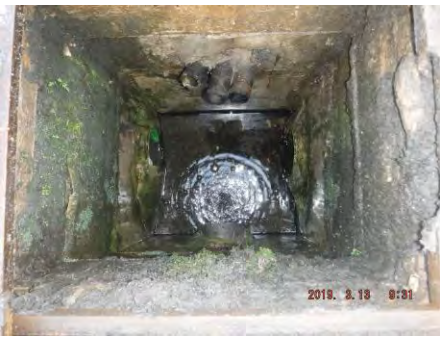
BASIN: G
 STRUCTURE NO. G-9
1003

I.E. #1: 142.8 (N)
 I.E. #2: 143.7 (E)
 I.E. #3: 142.9 (S)
 I.E. #4: Unk (W)
 T.G.: 147.1

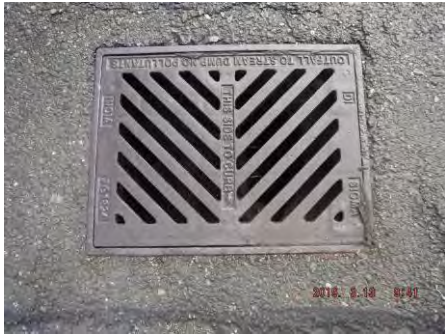
BASIN: G
STRUCTURE NO. G-10
1005

I.E. #1: NA
I.E. #2: 143.5 (E)
I.E. #3: NA
I.E. #4: NA
T.G.: 145.5

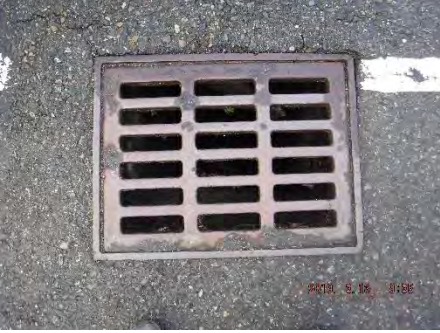
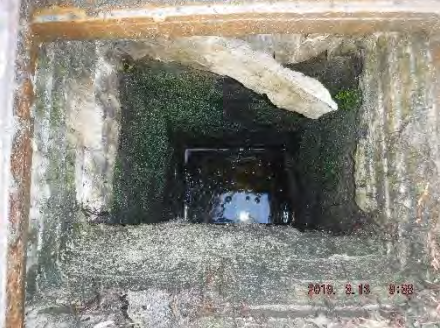
BASIN: G
 STRUCTURE NO. G-11
1004

I.E. #1: 140.9 (N)
 I.E. #2: NA
 I.E. #3: 141.2 (S)
 I.E. #4: 142.6 (W)
 T.G.: 145.5

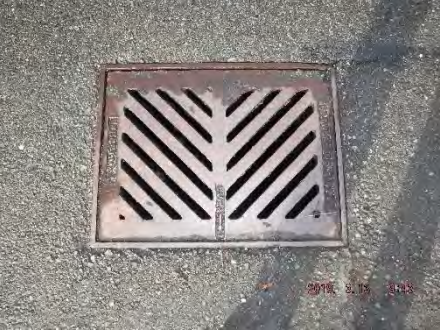
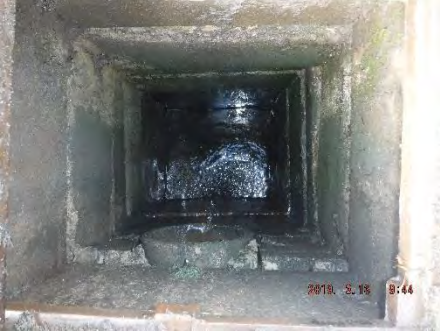
BASIN: G
 STRUCTURE NO. G-12
1006

I.E. #1: 139.1 (N)
 I.E. #2: 142.6 (E)
 I.E. #3: 139.2 (S)
 I.E. #4: NA
 T.G.: 145.0

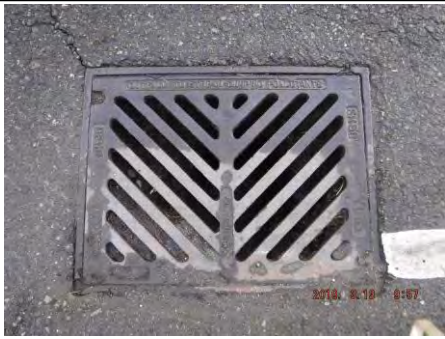
BASIN: G
STRUCTURE NO.: G-13
1008

I.E. #1: NA
 I.E. #2: 139.9 (W)
 I.E. #3: NA
 I.E. #4: NA
 T.G.: 141.5

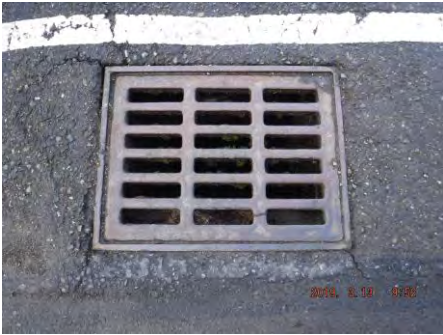
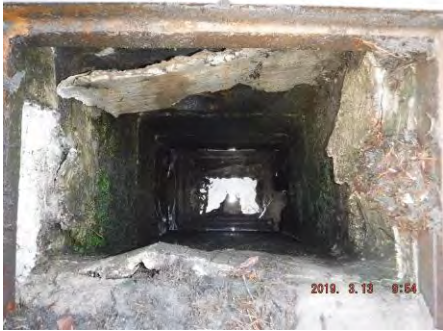
BASIN: G
 STRUCTURE NO. G-14
1007

I.E. #1: 136.5 (N)
 I.E. #2: NA
 I.E. #3: 136.4 (S)
 I.E. #4: 138.9 (W)
 T.G.: 141.5

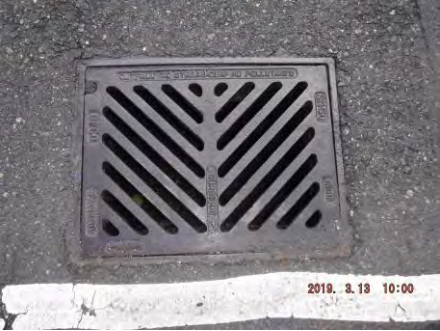
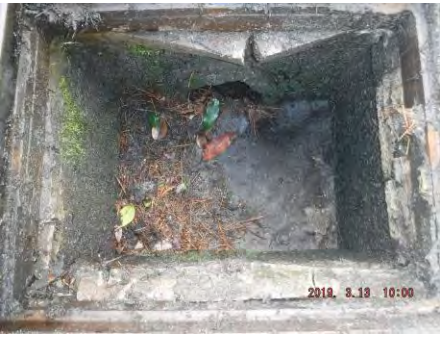
BASIN: G
 STRUCTURE NO. G-15
1009

I.E. #1: NA
 I.E. #2: 134.8 (E)
 I.E. #3: NA
 I.E. #4: NA
 T.G.: 136.6

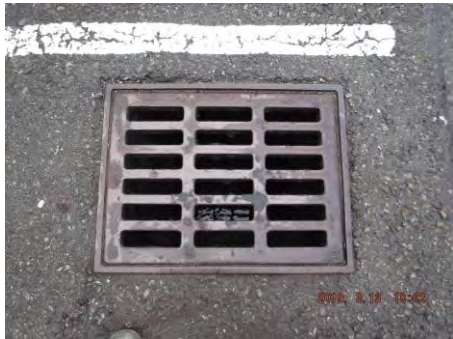
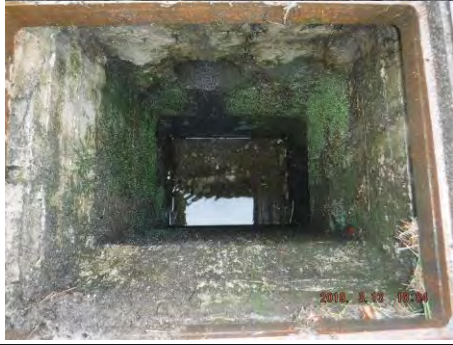
BASIN: G
 STRUCTURE NO. G-16
1010

I.E. #1: 131.9 (N)
 I.E. #2: NA
 I.E. #3: 132.0 (S)
 I.E. #4: 134.2 (W)
 T.G.: 136.5

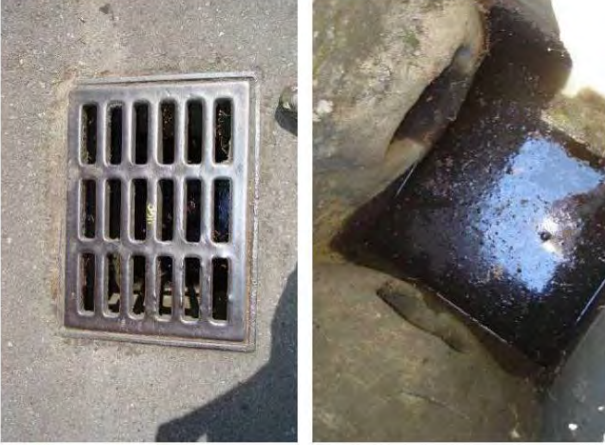
BASIN: G
 STRUCTURE NO. G-17
1160

I.E. #1: NA
 I.E. #2: NA
 I.E. #3: 171.7 (S)
 I.E. #4: 171.6 (W)
 T.G.: 174.3

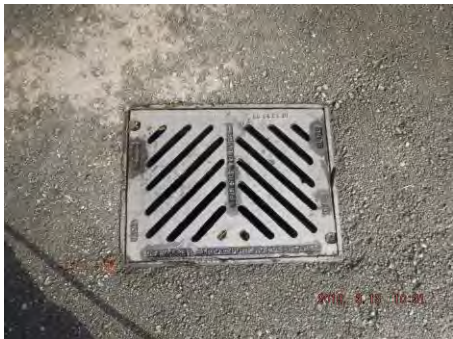
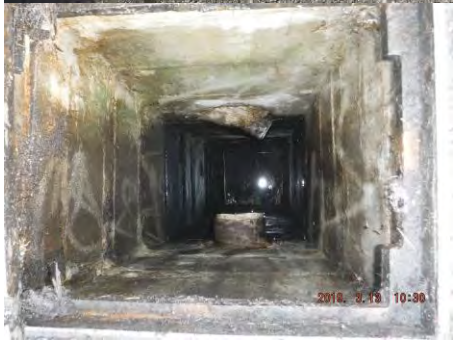
BASIN: G
STRUCTURE NO. G-19
1159

I.E. #1: 171.6 (N)
 I.E. #2: NA
 I.E. #3: 171.4 (S)
 I.E. #4: NA
 T.G.: 175.6

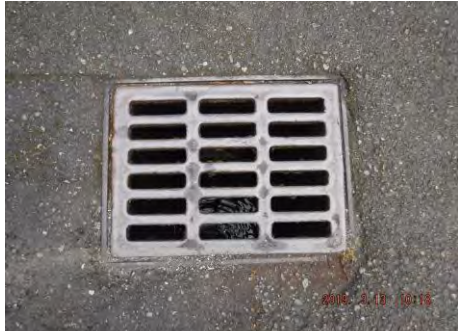
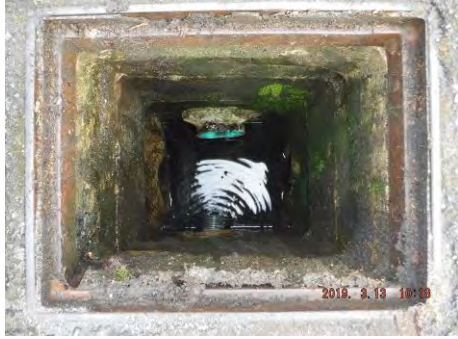
BASIN: G
 STRUCTURE NO. G-20
 1162

I.E. #1: 171.0 (N)
 I.E. #2: 170.8 (E)
 I.E. #3: NA (S)
 I.E. #4: 170.8 (W)
 T.G.: 175.3

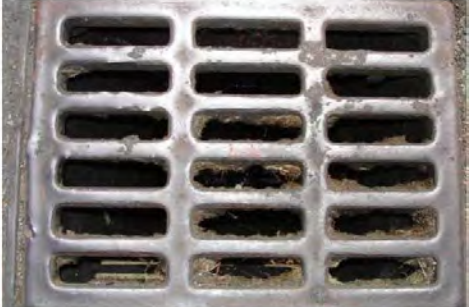
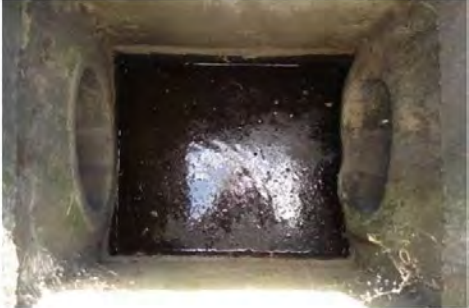
BASIN: G
 STRUCTURE NO. G-23
1155

I.E. #1: NA
 I.E. #2: 164.5 (E)
 I.E. #3: NA
 I.E. #4: 164.4 (W)
 T.G.: 168.1

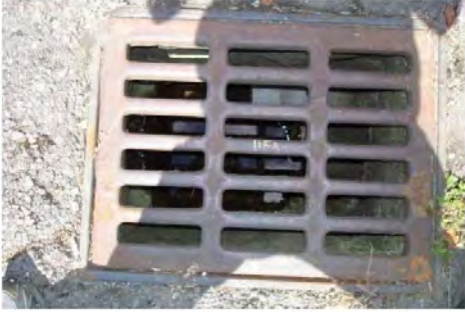
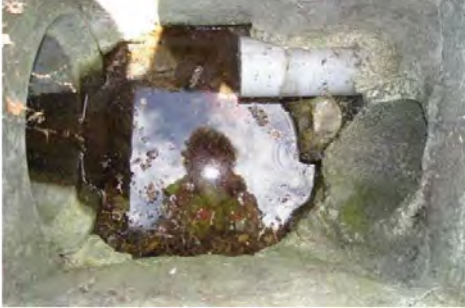
BASIN: G
STRUCTURE NO. G-24
1154

I.E. #1: 154.0 (E)
 I.E. #2: 154.2 (E)
 I.E. #3: NA
 I.E. #4: 154.1 (W)
 T.G.: 155.9

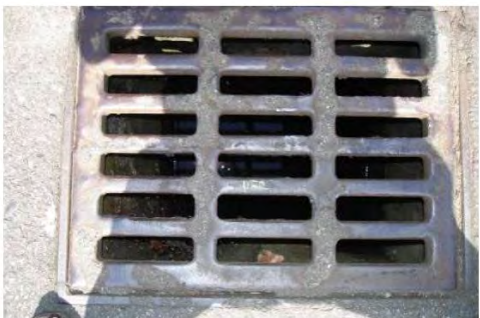
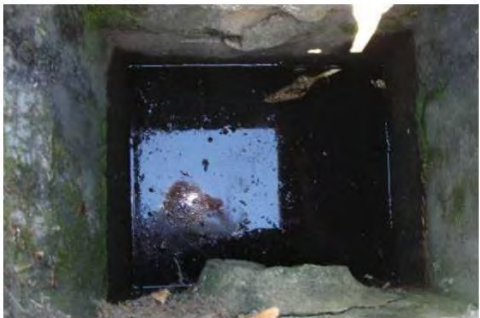
STRUCTURE NO. G-26
1152

I.E. #1: 150.6 (NE)
 I.E. #2: NA
 I.E. #3: 150.4 (S)
 I.E. #4: NA
 T.G.: 152.9

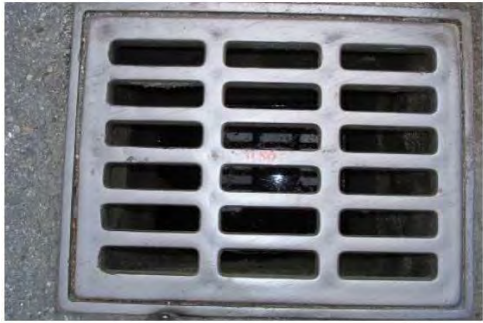
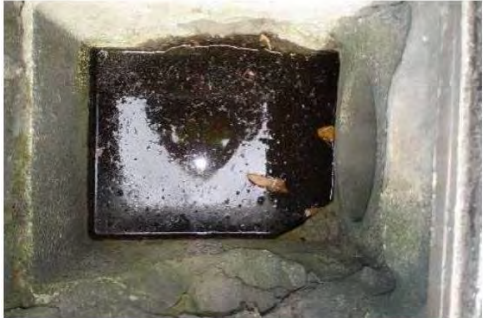
BASIN: G
 STRUCTURE NO. G-29
1150

I.E. #1: 134.3 (N)
 I.E. #2: 134.5 (E)
 I.E. #3: 135.2 (S)
 I.E. #4: NA
 T.G.: 136.9

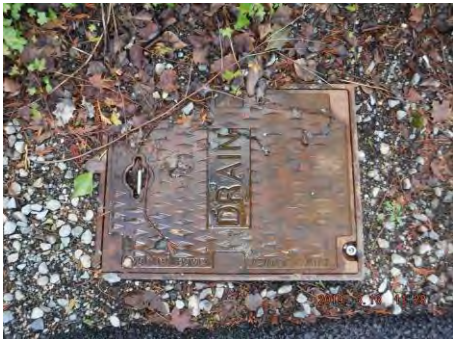
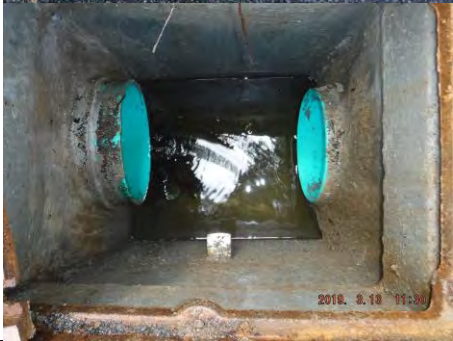
BASIN: G
 STRUCTURE NO. G-33

D. Other – Describe: PVC connects to broken concrete pipe a short distance downstream near G-34.

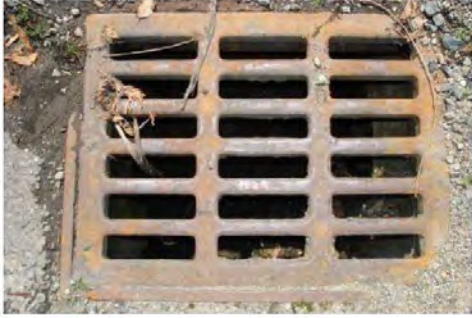
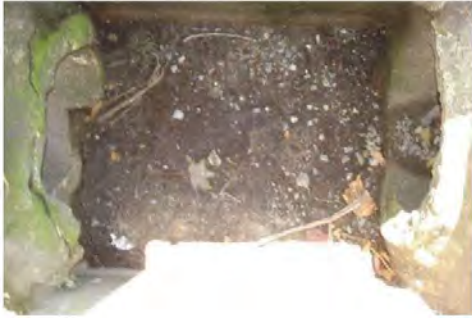
BASIN: G
 STRUCTURE NO. G-34
1148

D. Other – Describe: Concrete pipe upstream is broken and disconnected from 12" PVC G-33.

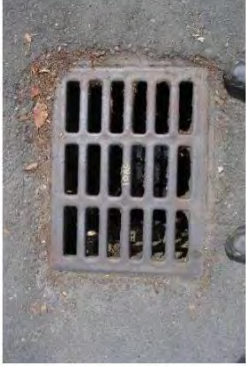
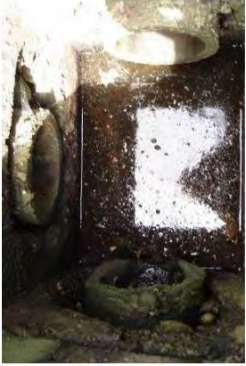
D. Other – Describe: ~28 LF downstream of this CB is 4 LF section of CMP; needs CIP to get replaced.

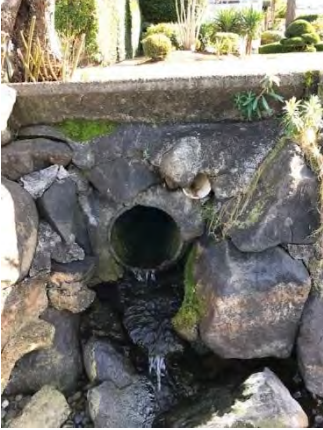
BASIN: H
STRUCTURE NO. H-22

Comments: Clean and video 2018. Heavy roots; several broken pieces; pipe wanders just upstream of H-20 to lake.

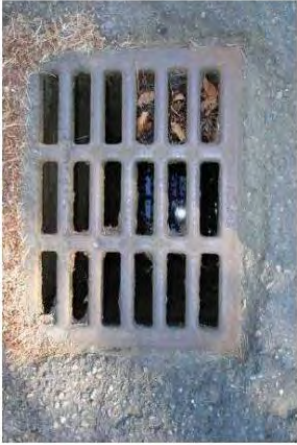
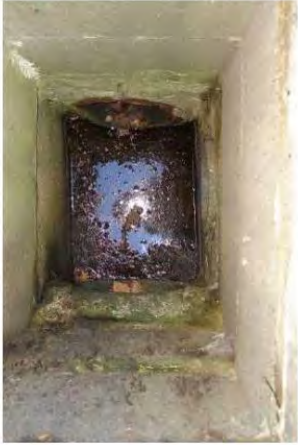
BASIN: J
 STRUCTURE NO. J-10
1075

D. Other – Describe: Defective top with exposed rebar in storm mainline; 58 LF N of this CB.

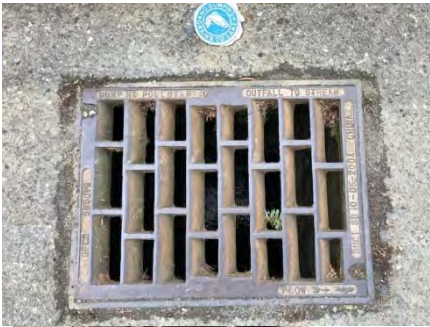
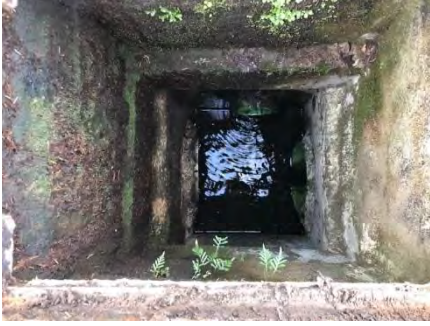
BASIN: J
 STRUCTURE NO. J-11
1074

D. Other – Describe: Defective top with exposed rebar in storm mainline; 25 LF S of this CB.

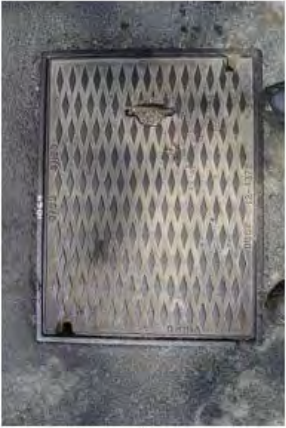
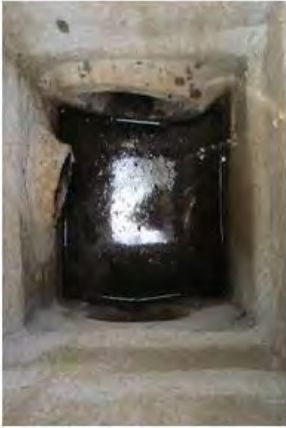
BASIN: J
 STRUCTURE NO. J-21
1064

I.E. #1: 82.9 (N)
 I.E. #2: NA
 I.E. #3: 83.0 (S)
 I.E. #4: 83.9 (W)
 T.G.: 88.0

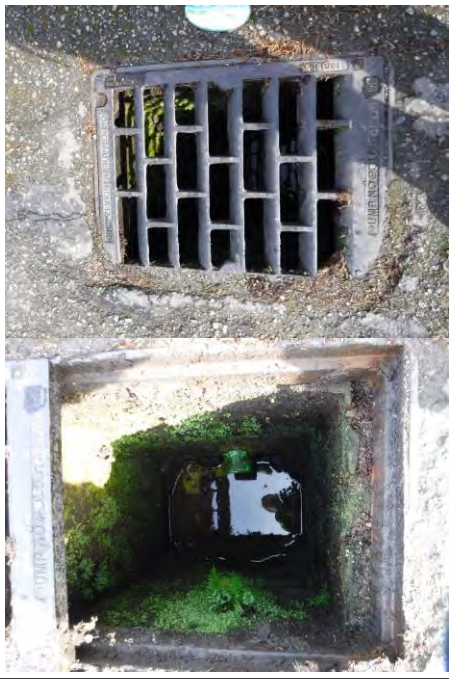
BASIN: J
 STRUCTURE NO. J-22
 1063

I.E. #1: NA
 I.E. #2: 79.9 (E)
 I.E. #3: NA
 I.E. #4: 79.4 (W)
 T.G.: 82,8

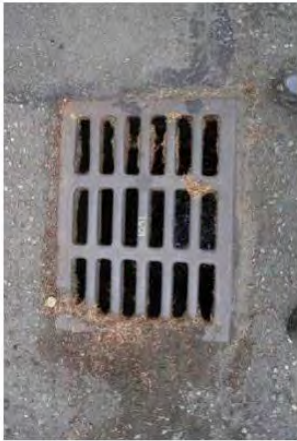
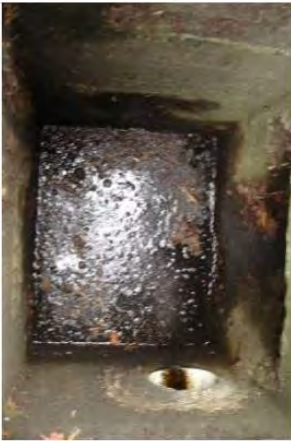
BASIN: J
 STRUCTURE NO. J-31
1091

I.E. #1: 137.4 (N)
 I.E. #2: 137.4 (E)
 I.E. #3: 137.9 (S)
 I.E. #4: 137.5 (W)
 T.G.: 140.6

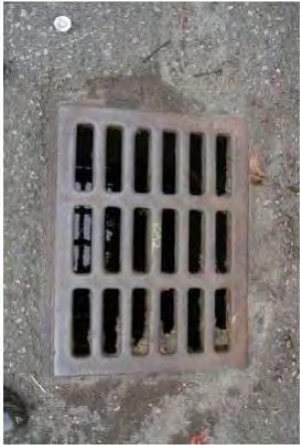
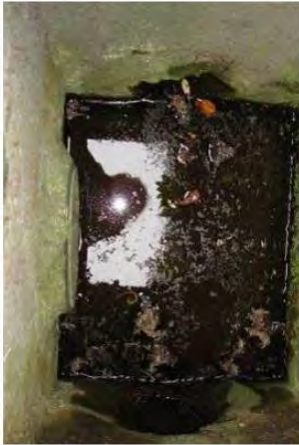
BASIN: J
 STRUCTURE NO. J-33
1092

D. Other – Describe: 123 LF N of J-33 8" storm mainline broken w/ 1" diameter gray conduit bore.

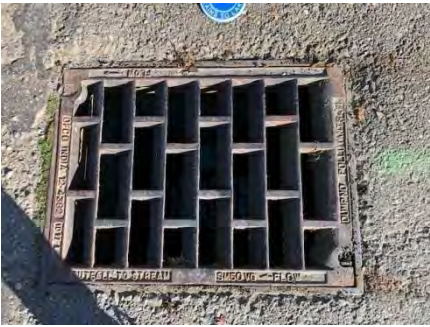
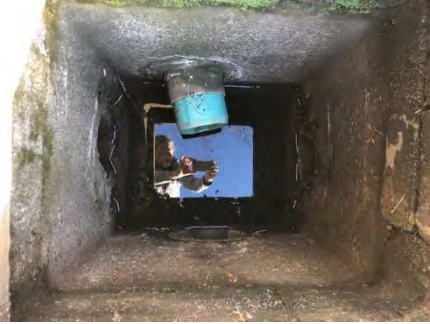
BASIN: J
 STRUCTURE NO. J-35
1095

D. Other – Describe: 25 LF 8" mainline is broken open - 8" hole at NW side.

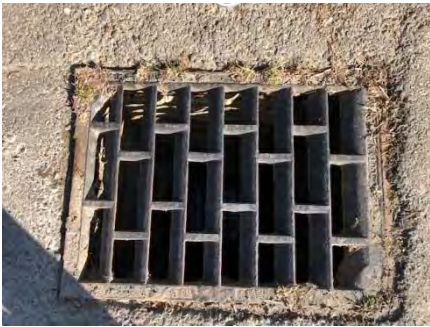
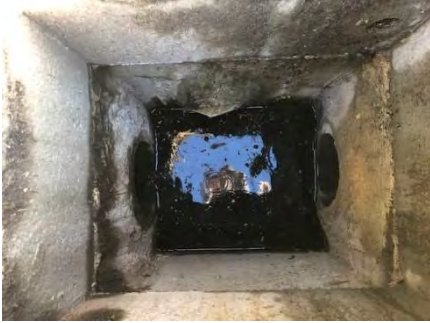
BASIN: J
 STRUCTURE NO. J-47
1027

10" CONC
Abandoned 2016

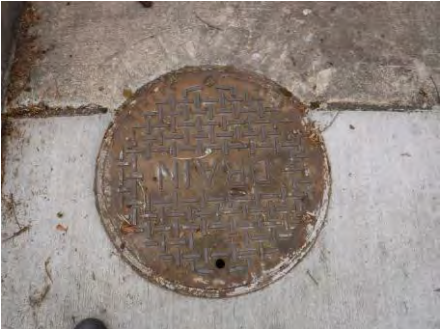
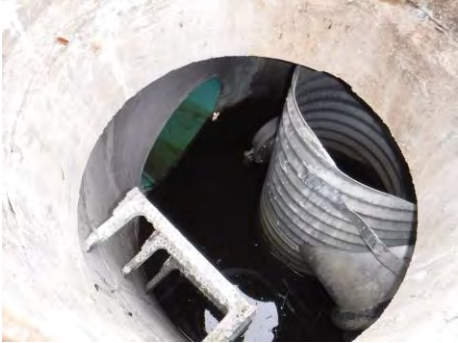
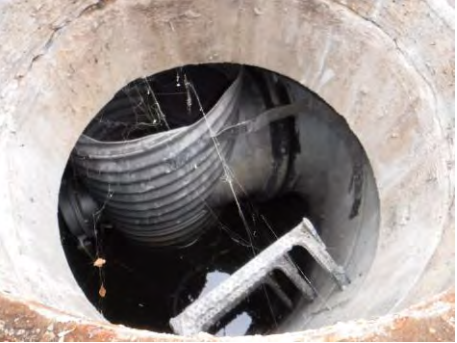
BASIN: J
 STRUCTURE NO. J-67
1109

Comments: SHEAR GATE HANDLE MISSING. APPROX. AGE 11 years; installed 2009.
 Clean and video 2019.
